हिमनदों पर गठित विशेषज्ञ समिति द्वारा मा. मुख्य मंत्री महोदय को प्रतिवेदन प्रस्तुत

Devpuri disaster of July, 2007

Panjan landslide

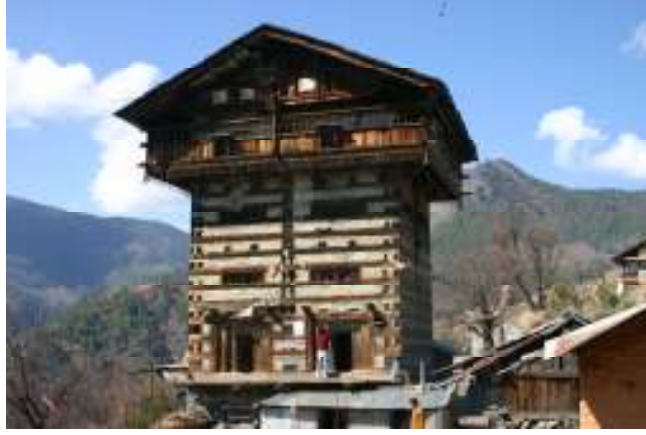
Four and five storied traditional structures (identified as *Chaukhat* and *Panchapura* respectively) can still be seen in Yamuna and Bhagirathi valleys. Having built 700 – 900 years before present these must have witnessed a few major earthquakes (Kumaun Earthquake of 1720 and Garhwal Earthquake of 1803) and in the absence of the elements of earthquake safety these would have been razed to ground.

Armed with the zeal to protect the community and experimenting with locally available building material the inhabitants of the region evolved a unique architectural style that exhibits structural evolution trends whereby dry stone masonry, as also stone – lime / mud / clay mortar masonry was judiciously used with abundantly available wood to provide appropriate strength and flexibility to the structures.

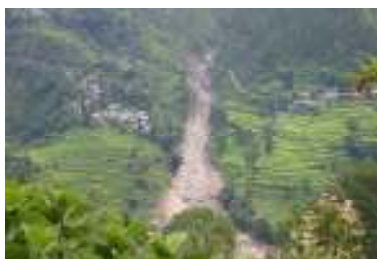
Panjan village is situated in Jakholi block of Rudraprayag district and falls in the catchment of Lastar Gad, a tributary of Mandakini river. The village is situated over an old slide where rich soil development has led to human settlement and cultivation. The evidence of slow creep are observed in the slope.

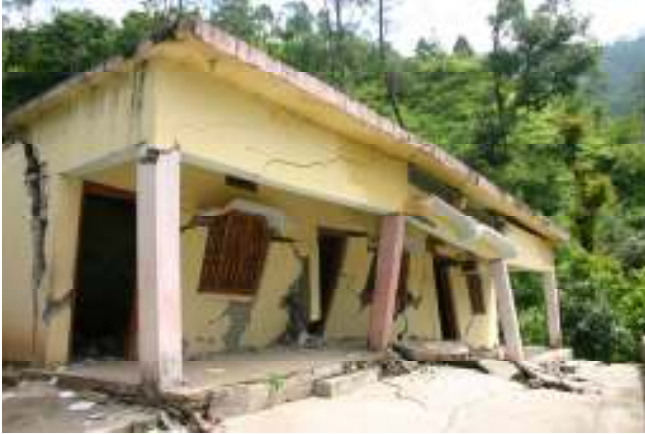
Mass movement initiated at the upper hill slope amid forest area in the early hours of 6th July, 2007 amid heavy rain. Heavy downpour resulted in the rolling down of material and the consequent erosion added loose material to the surface runoff. Erosion of the soil mass enhanced density of the surface flow resulting in its enhanced erosive strength together with the carrying capacity. The magnitude of the force of the moving water can well be adjudged by the deep scouring and movement of huge boulders.

Removal of the toe support by the erosion rejuvenated the old slide and scar started to initiate in the upper portion. This resulted in the differential ground movement near the scar. Two houses down slope of the fissures gave way due to this while a few others in the vicinity sustained minor cracks. Loss of human lives was however averted by timely evacuation of the affected houses.

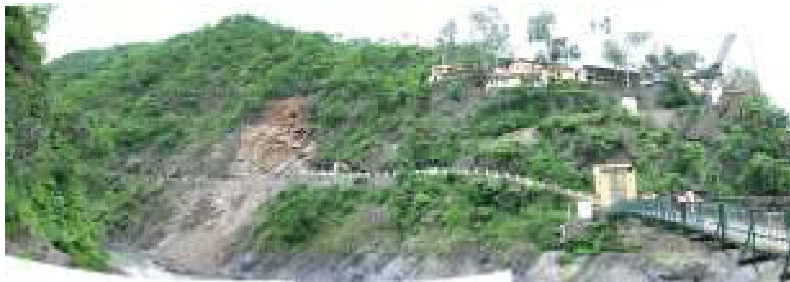
A north south running ridge separates the catchments of Mandakini and Alaknanda rivers near their confluence at Rudraprayag, where the temple of Rudranath is situated.

The motor road leading to Gaurikund (Kedarnath) passes through a 65 meters long tunnel that was constructed in 1957 across the ridge near the confluence. After the tunnel the road follows the left bank of Mandakini river. The valley slopes are steep and the exposed rocks are highly weathered and show two distinct sets of joints with appreciable dilation. Relationship of the foliation planes with the joints provides favourable conditions for wedge failure. The site witnesses frequent rockfall and is a major threat for the traffic.

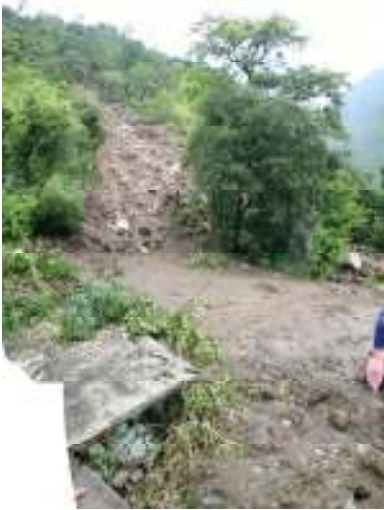
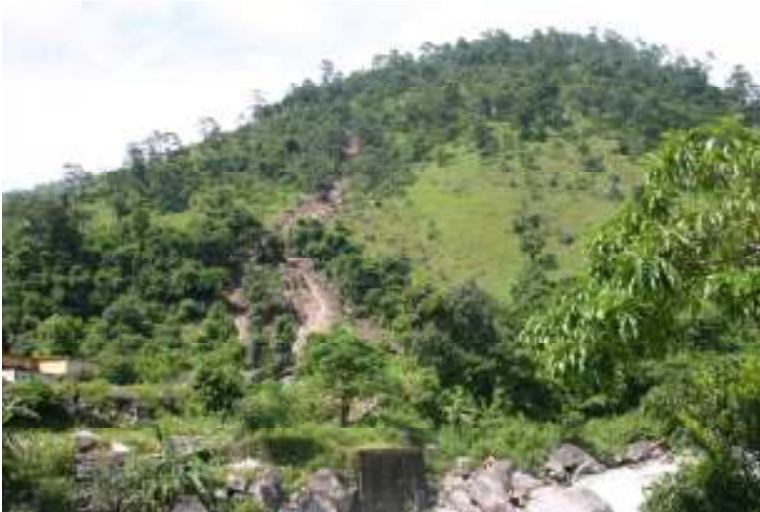
In the Goriganga valley of Pithoragarh district landslide took place in the midnight of 5th September, 2007 at Baram and Maitali that are located in close proximity on the Jauljibi – Munsyari motor road. At Malla Sain (*tok* of Baram affected by slide) a series of houses were constructed in the colluvial terrace at the slope break below the forest land. The slope above the houses comprises mostly old slide material that was stabilized and where appreciable vegetative growth had taken place.

The area witnessed heavy rains in the midnight of 5th September, 2007. Soil mass together with the embedded boulders broke loose around 60 meters upslope of the habitation at Malla Sain. It was thick mudflow that ravaged the houses. Four houses were destroyed (with three being completely razed to ground) and the event took toll of 10 human lives. As the slide had initiated at a short distance above the habitations the debris could not gather enough momentum and got piled up in the terrace. Later debris flow from this stage overrun the fields below.
